ANALYTICAL AND EXPERIMENTAL
INVESTIGATION OF AIRCRAFT
METAL STRUCTURES REINFORCED
WITH FILAMENTARY COMPOSITES

Phase II - Structural Fatigue, Thermal Cycling,
Creep, and Residual Strength

by B. Blichfeldt and J. E. McCarty

Prepared by
THE BOEING COMPANY
Seattle, Wash. 98124
for Langley Research Center

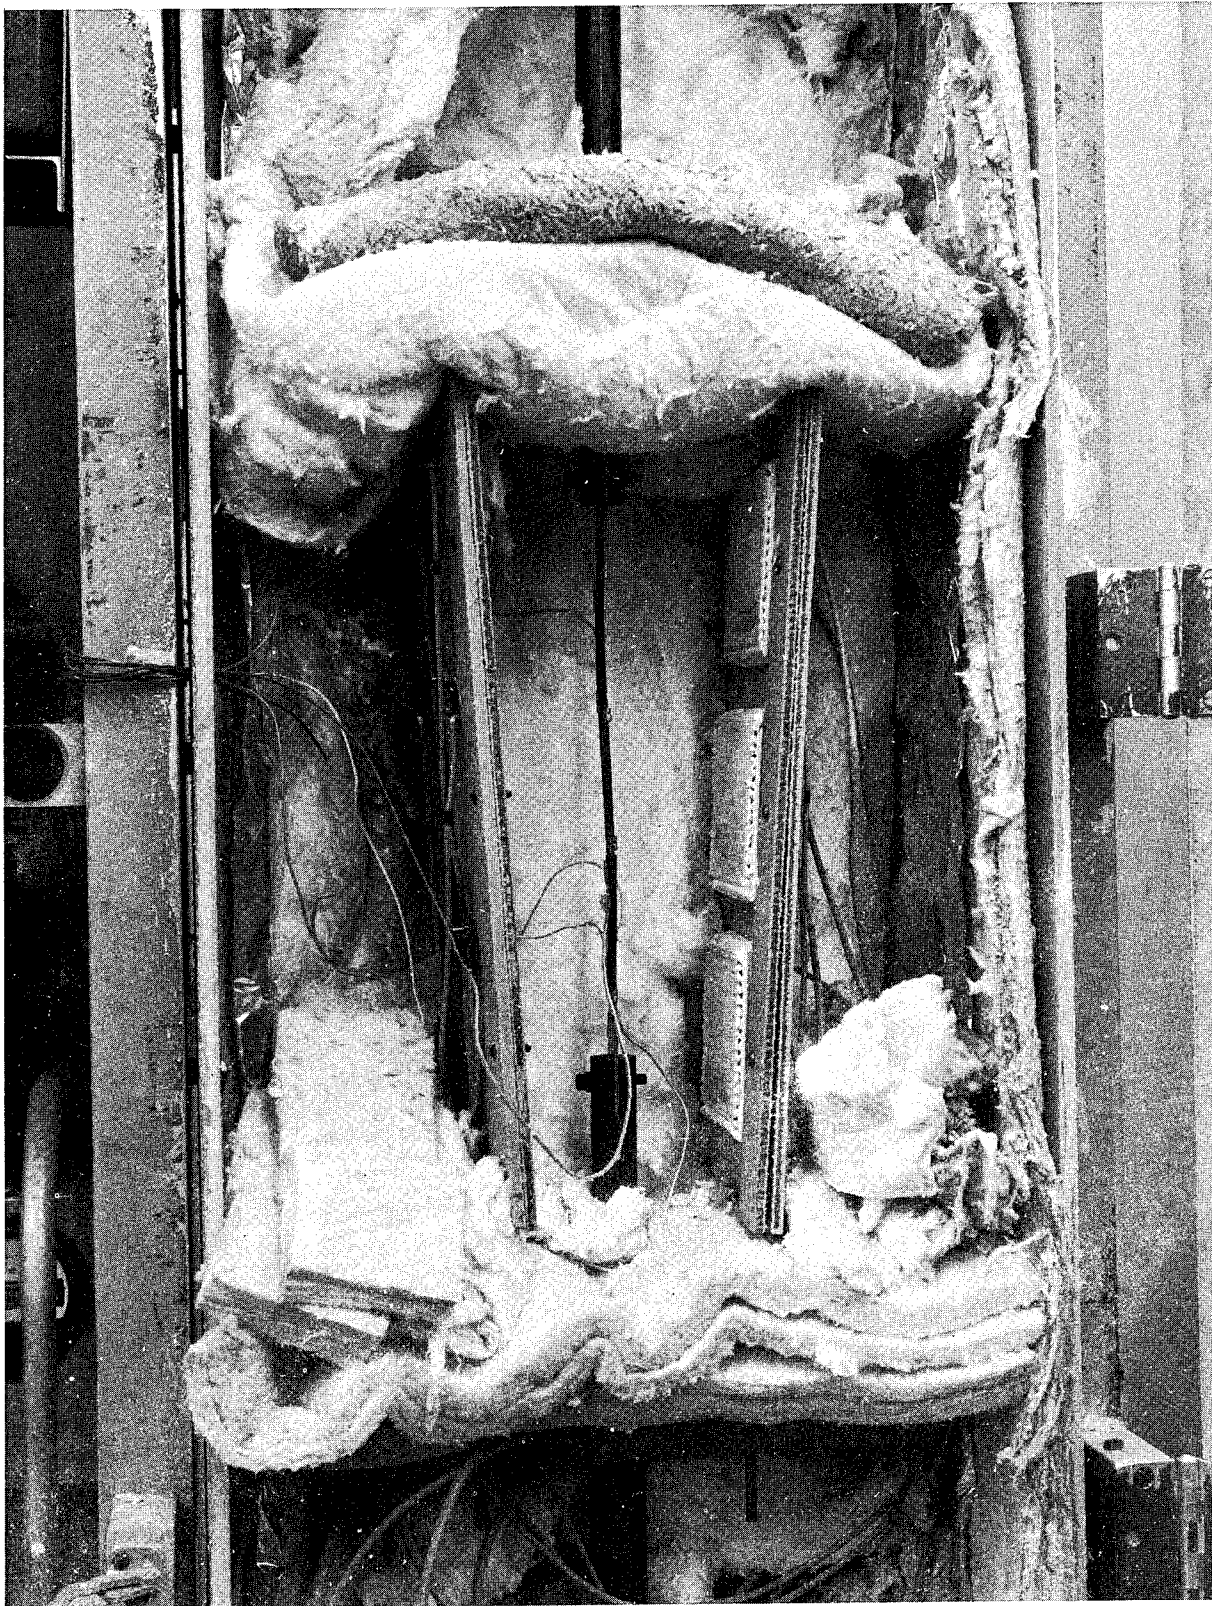
FIGURE 22.—CREEP AND RUPTURE TEST SETUP

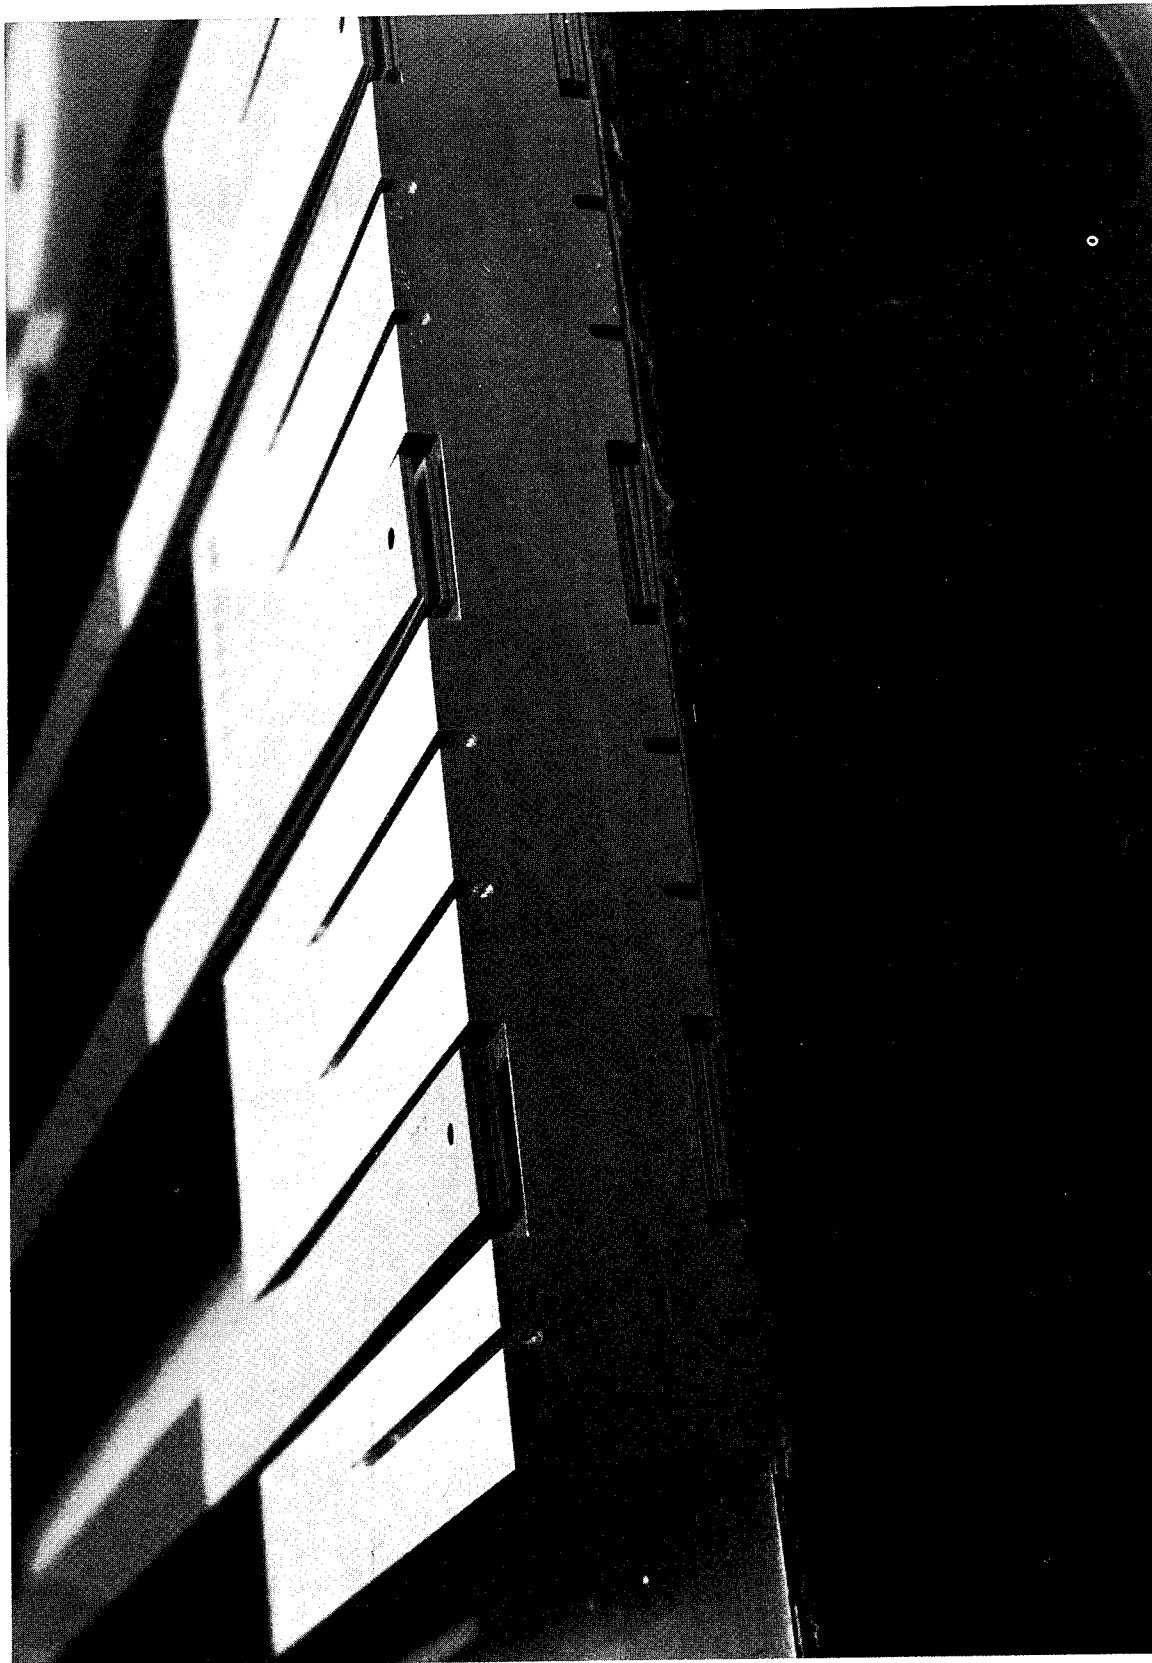
FIGURE 29.—DETAIL OF GRIP PLATE FOR CONCEPT 2c
